# Reconstruction of the Right Ravelin Caponier of the Boyen Fortress in Giżycko – Conservation and Structural Analysis

The article presents the reconstruction project of the right ravelin caponier of the Boyen Fortress in Giżycko — a 19th-century Prussian fortification — with particular emphasis on conservation and structural aspects. In 2022, the structure suffered a major building failure (collapse of a wall and vaults), which necessitated comprehensive repair and restoration works. An analysis of the caponier's condition prior to the failure was carried out, and the causes of the collapse were identified. A conservation program was developed, including the stabilization and anastylosis (reconstruction from preserved original elements) of the historic structure. The design assumptions for the reconstruction are presented, along with an analysis of the materials used (bricks and mortar) and the structural and masonry solutions ensuring the durability and authenticity of the monument. A detailed numerical analysis using the Finite Element Method (FEM) was performed in Autodesk Robot Structural Analysis Professional, modeling the caponier's vaults and walls under permanent and serv

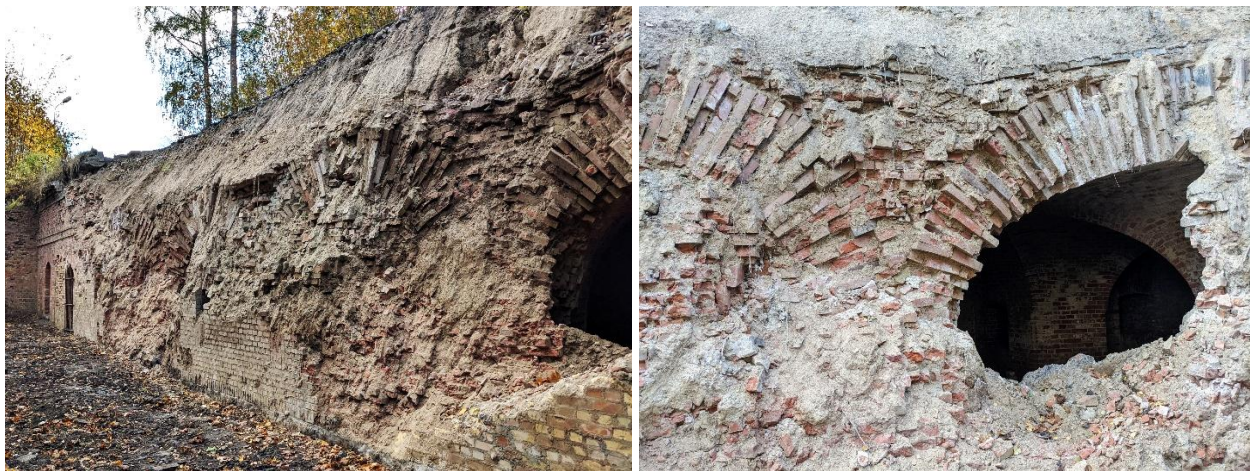
In mid-2022 a sudden structural failure occurred. During the night of 18–19 July 2022, near the Kętrzyn Gate, a significant volume of soil slid downward, causing a section of the road running above the caponier to subside. As a consequence, the front façade of the semi-ravelin caponier collapsed together with fragments of its vaults (Fig. 1).

**Fig. 1.** Condition of the right ravelin caponier immediately after the collapse (19 July 2022).

Determining the precise causes required technical investigations (including geotechnical studies) and expert assessments. However, initial observations already indicated a long-term accumulation of adverse factors. The most probable direct cause was overloading of the structure due to the passage of a heavy vehicle (a lorry) along the road situated above the caponier. A clear tyre mark of a large vehicle was visible at the edge of the resulting landslide, suggesting that the weight and vibrations associated with the vehicle's movement could have triggered instability in the already weakened structure [5][6].

It is important to emphasise that the caponier had never been designed to carry high-tonnage vehicular loads; in the nineteenth century, such structures were intended to bear only a layer of earth and pedestrian or horse traffic. Another significant contributing factor was prolonged neglect: the lack of maintenance and repair works led to degradation of mortar joints and portions of the brickwork, as well as the development of deep fissures [6][7]. Rainwater infiltrated through these discontinuities, softening the soil and reducing the adhesion between the earth fill and the vaults. Repeated freeze–thaw cycles exerted further destructive effects on the masonry. Finally, original structural vulnerabilities may also have played a role—historical damage (e.g. from attempted demolition or the action of tree roots) could have reduced the caponier's load-bearing capacity.

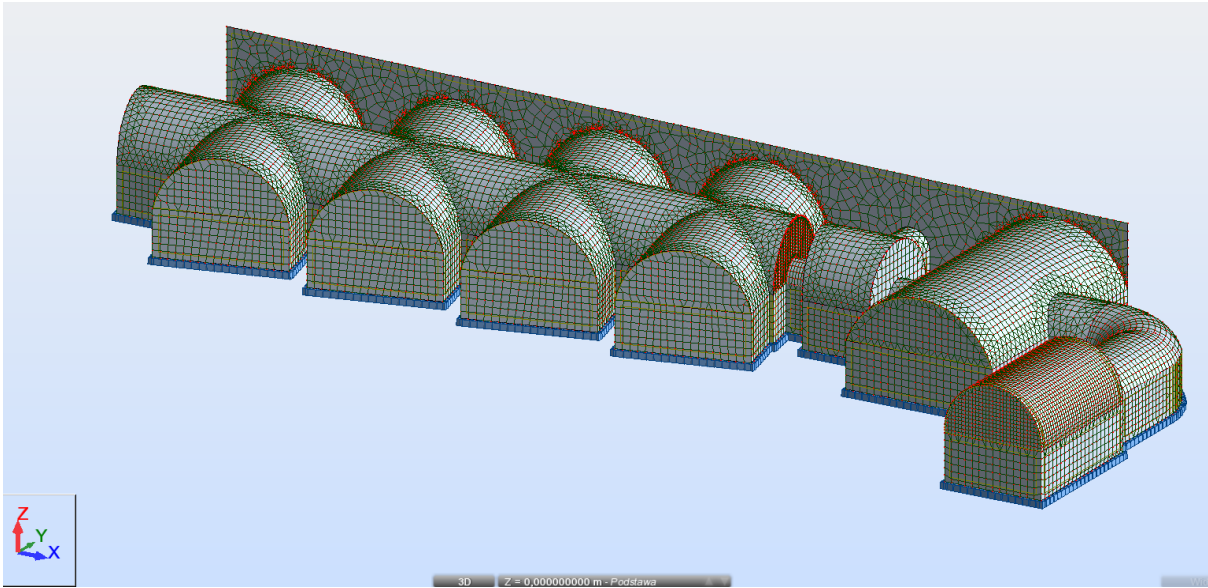
- a full model including the analysed wall (Fig. 2),
- a model with the damaged wall removed (Fig. 3).

**Fig. 2.** Full numerical model of the caponier (with the wall) with the FEM mesh applied

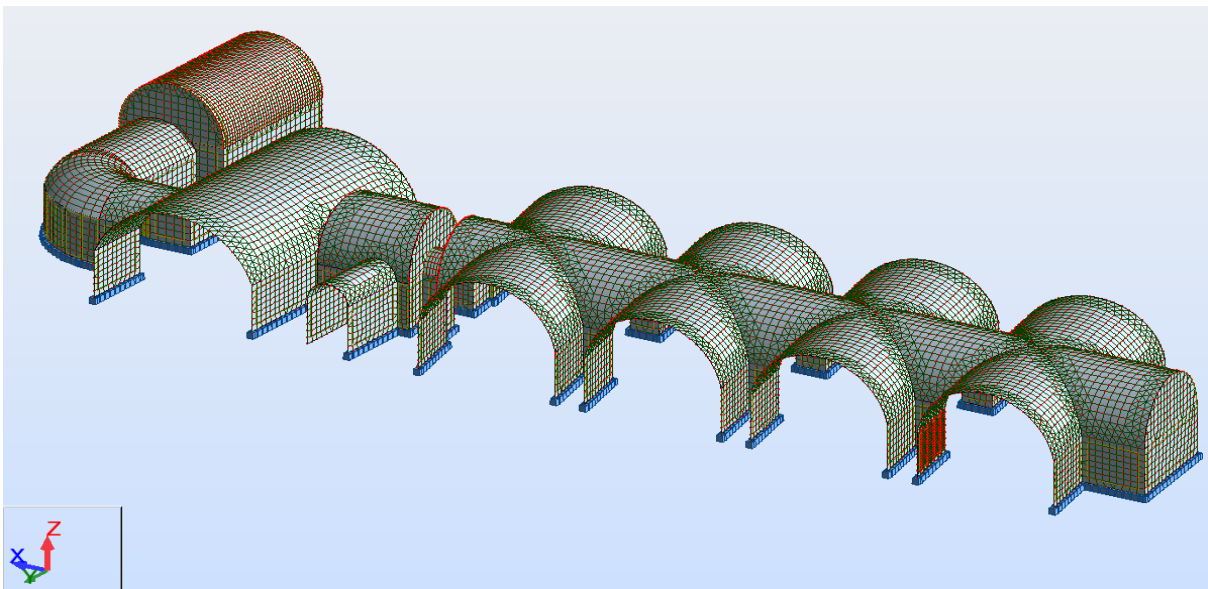
The “no-wall” model demonstrates that the wall failure did not compromise the overall stability of the caponier. Consequently, it is not necessary to provide full temporary propping of the rooms adjacent to the analysed wall. The repair works can be carried out by shoring only the damaged, locally affected vault segments using telescopic props. Full, continuous centring of the vaults is not required.

**Fig. 3.** Numerical model of the caponier with the damaged wall removed
