Revitalizing the Sacral Complex of the Parish of the Sacred Heart of Jesus in Gdynia: A Comprehensive Restoration Project in Alignment with Monument Conservator's Guidelines and Technical Prerequisites

Maciej NIEDOSTATKIEWICZ^{*1}, Jacek BRAMORSKI^{2,3}

¹ Department of Engineering Structures, Faculty of Civil and Environmental Engineering,
Gdańsk University of Technology, Gdańsk, Poland

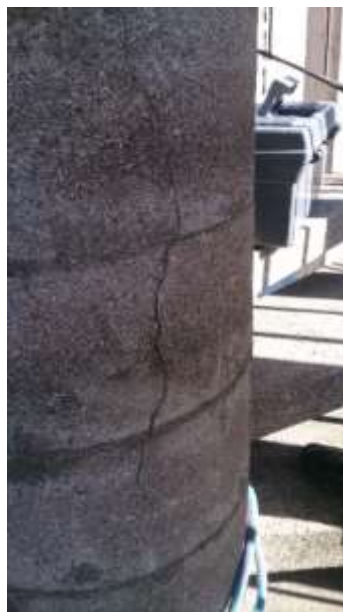
Photo 5. Outlined, in the line of the axial anchorage, prefabricated steps of the spiral stairs leading to the top of the belfry tower (photo by Maciej Niedostatkiewicz)

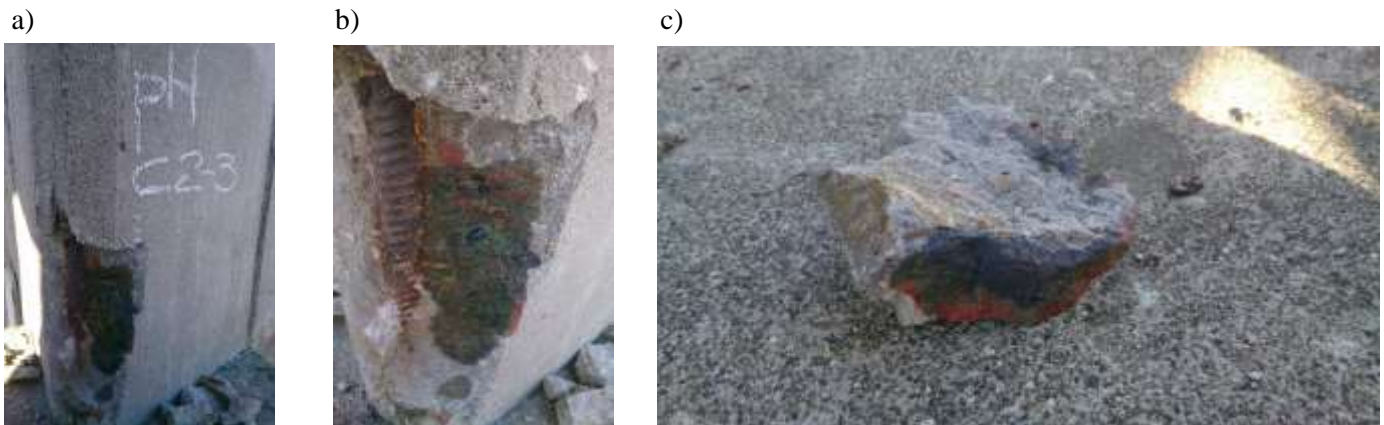
Photo 6. Exemplary results of measurements of the degree of concrete carbonation in the performed open pits: a) and b) discoloration of concrete on the main pillars of the bell tower from $pH=5$ to $pH=11$ and c) discoloration of the forged fragment of the concrete cover of the transom reinforcement bars from $pH=5$ to $pH=13$ (photo by Maciej Niedostatkiewicz)

- pole A3-4 (level 4) $pH = 7$,
- column C3-4 (level 4) $pH = 7$,
- column C2-3 (level 3) $pH = 9$,
- column A1-2 (level 2) $pH = 11$.

The obtained test results allowed to conclude that the concrete in the near-surface zone (cover) lost its ability to protect the reinforcement bars against corrosion [N7]. In the excavations, corrosion of the reinforcement bars was found: the measured corrosion losses of the bars were up to 2 mm in diameter of the main reinforcement bars and up to 1.50 mm in diameter of the transverse reinforcement bars (stirrups).

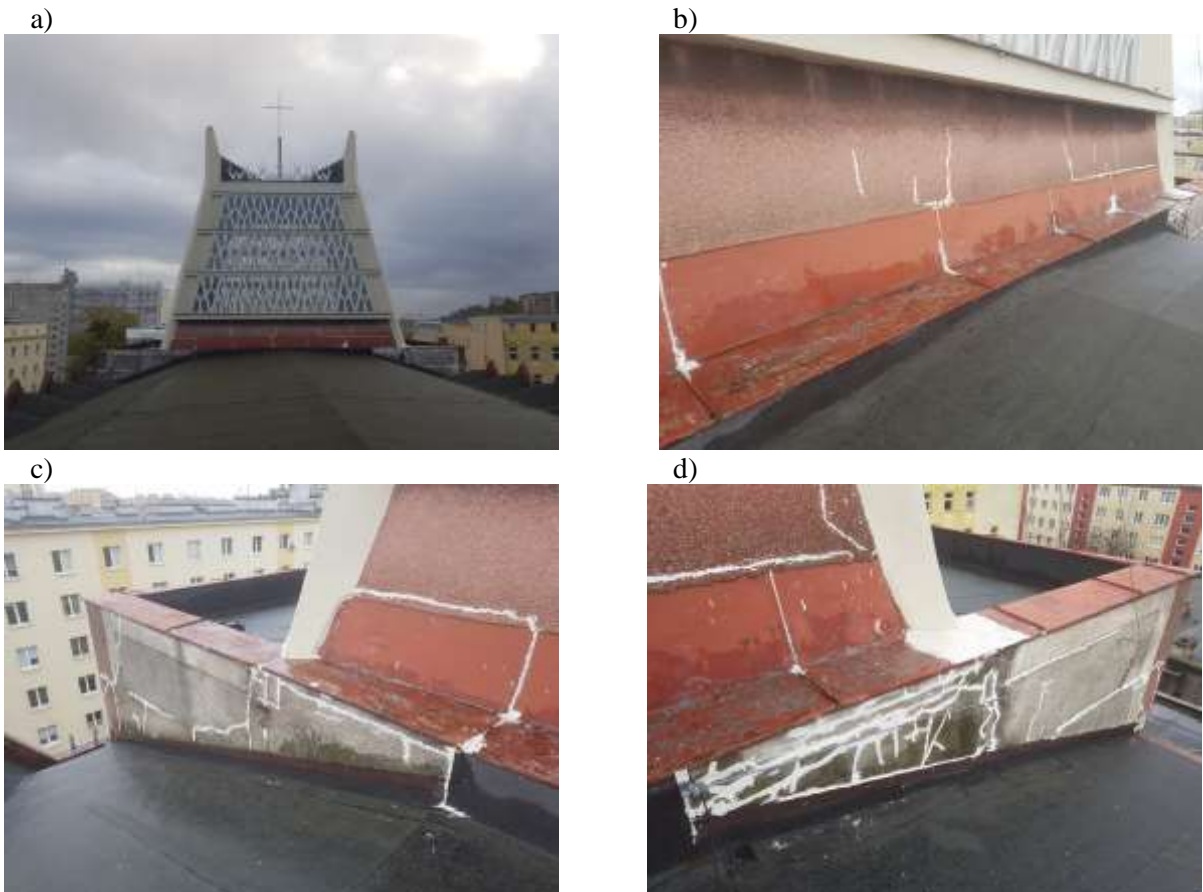
Photo 9. Roof of the Church of the SHoJ in Gdynia: a) general view towards the so-called lantern over the presbytery, b) cracks in the plaster of the lantern plinth, c), d) cracks in the plaster of the attic along the lantern, flashings of the attic along the lantern: e) before and f) after the replacement (photo by Maciej Niedostatkiewicz and Jacek Bramorski)

The renovation works also included the replacement of the existing, intensively depreciated flashings. The main scope of renovation works on the roof over the central nave included reprofiling the reinforced concrete gable beams of the roof slopes - the beams had numerous corrosion damages, the concrete cover of the reinforcement bars was falling off and extensive moisture damage was visible (Photo 10). The repair works included the reprofiling of reinforced concrete elements with the use of PCCI and PCC II repair compounds, taking into account the use of passivating materials for corroded reinforcing bars. The scope of renovation works also included the replacement of flashings and flashings of the roof slopes and the replacement of existing downpipes.

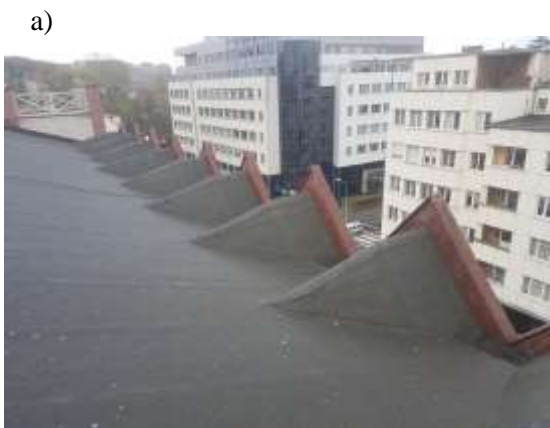
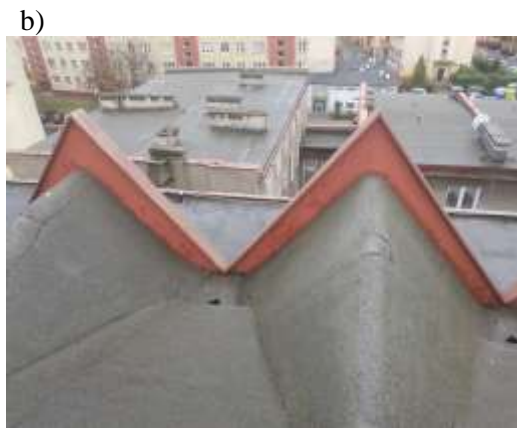
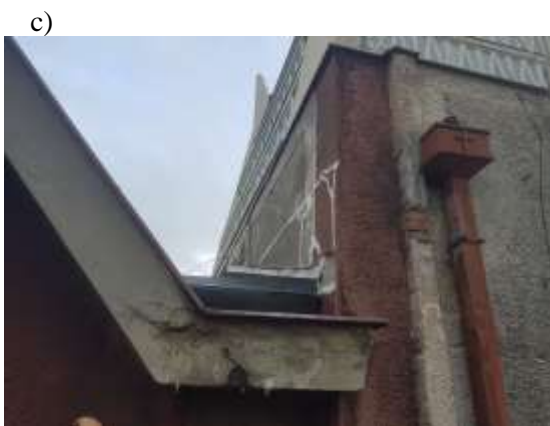
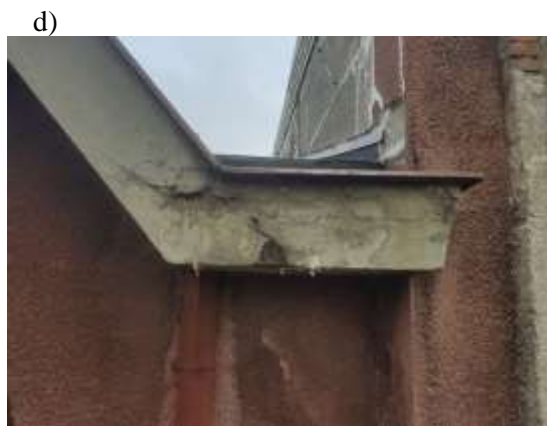
Photo 10. Shed roof over the nave of the Church of the SHoJ in Gdynia: view: a) general, b) close-up, c), d), e), f) examples of damage to the roof cornice (photo by Maciej Niedostatkiwicz)

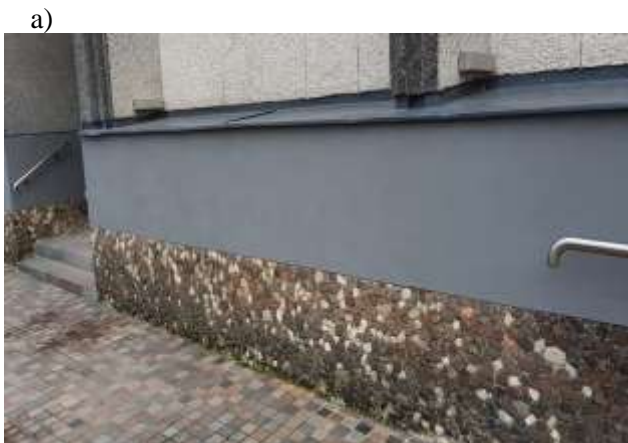
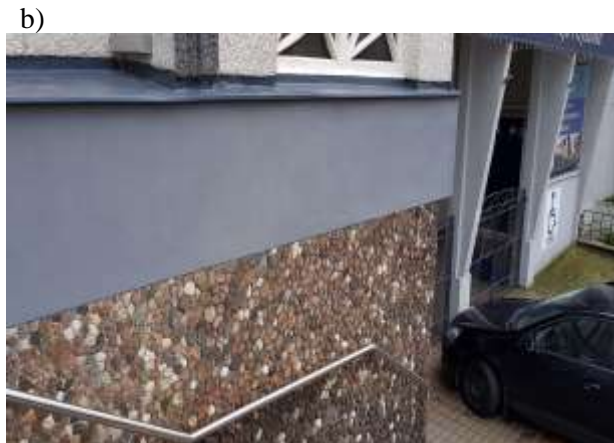
Photo 15. Base cornice after completion of renovation works: a), b) along the western elevation (from the side of 3 Maja Street), c) from the southern elevation (along Armii Krajowej Street), d) along the eastern elevation (from the side of Monsignore Hilarego Jastaka Street), e), f) from the northern elevation (along Stefana Batorego Street) (street names as of 2023) (photo by Maciej Niedostatkiewicz)

The lower part had damage similar to damage to the stone cladding of the wall at the main entrance. The stones were dirty, covered with a coating. Single stones were loosened, some of the joints were chipped. As part of the renovation works, the entire surface of the lower part of the plinth was first wetted with water at a temperature of $\sim 30^{\circ}\text{C}$, and then a thin layer of ammonium fluoride-based cleaning paste was applied to the surface of the plinth using a bench brush and the plinth was again washed with warm water. After cleaning, loose stones were glued in, and then the jointed stone cladding was supplemented with the materials used to repair the stone cladding of the wall at the main entrance.

The upper part of the plinth had damages in the form of plaster burns from the concrete base, the entire surface of the plaster was discolored and faded. As part of the renovation work, the scalded plaster was chipped off and restored. The new plaster was made as a layered plaster, with a primer layer and a top layer, after prior priming of the substrate and making a bond bridge. The top layer of the plaster was made as colored in the mass, with the use of fine quartz aggregate, with the use of a trass mortar dyed in the mass. The newly made external plaster on the plinth was made as rubbed plaster, with a structure matched to the structure of the plaster fragments left. After the local plaster repairs were completed, its entire surface was secured with an additional protective paint coating, in accordance with the conservation guidelines - a silicone facade paint was used, characterized by high water vapor diffusivity. As part of

the repair work, the flashings on the upper surface of the plinth were also replaced. The original flashings were made of zinc sheet, joined with the use of reflected and smooth coils, they were replaced with flashings made of steel-titanium sheet joined with standing seams.

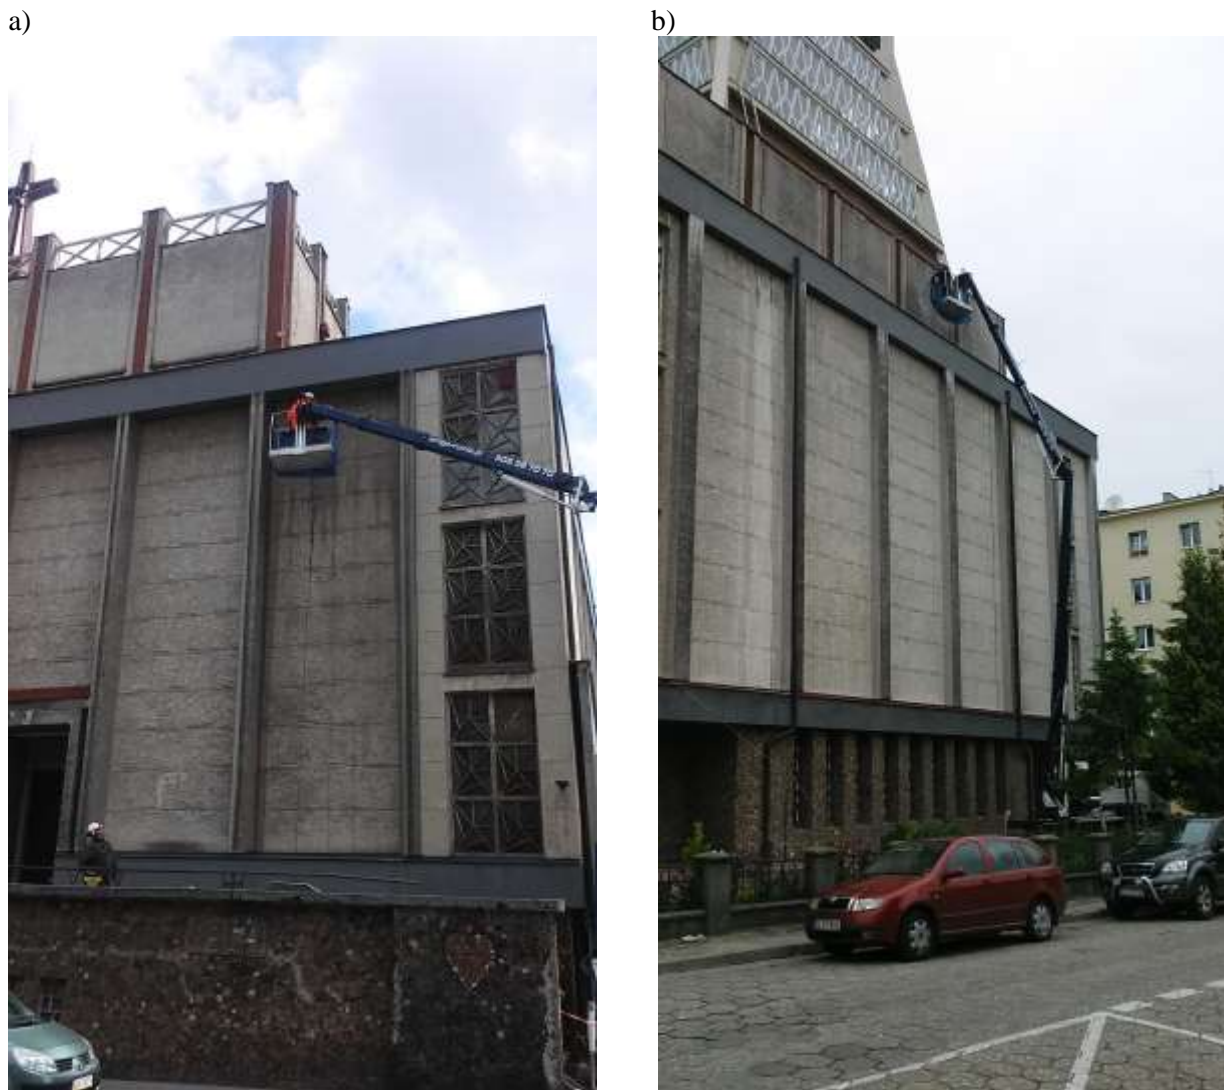
Photo 16. Church facades during their cleaning: a) western (from the side of 3 Maja Street) and b) eastern (from the side of Monsignore Hilarego Jastaka Street) (street names as of 2023) (photo by Jacek Bramorski)

The next stage of the renovation works of the Church building was the cleaning of the elevation (Photo 16). All facades of the building were subjected to restoration works, which were cleaned using the hydromonitoring method (Photo 17), using hot water at a temperature of 30°C. As an addition to the purification, an agent with a neutral pH was used, containing surfactants, i.e. surfactants that lower the surface tension of water. Thanks to the emulsifying properties of the agent used, the washed dirt and impurities were bound, especially the layer of grease and dust accumulated over the years of operation on the surface of the plaster made as the so-called. scraper. After cleaning, the facades were not additionally secured with a protective paint coating with the addition of anti-algae and anti-fungal agents, it was assumed that the protection would be provided by preservatives used in the production of the detergent in order to obtain its durability.

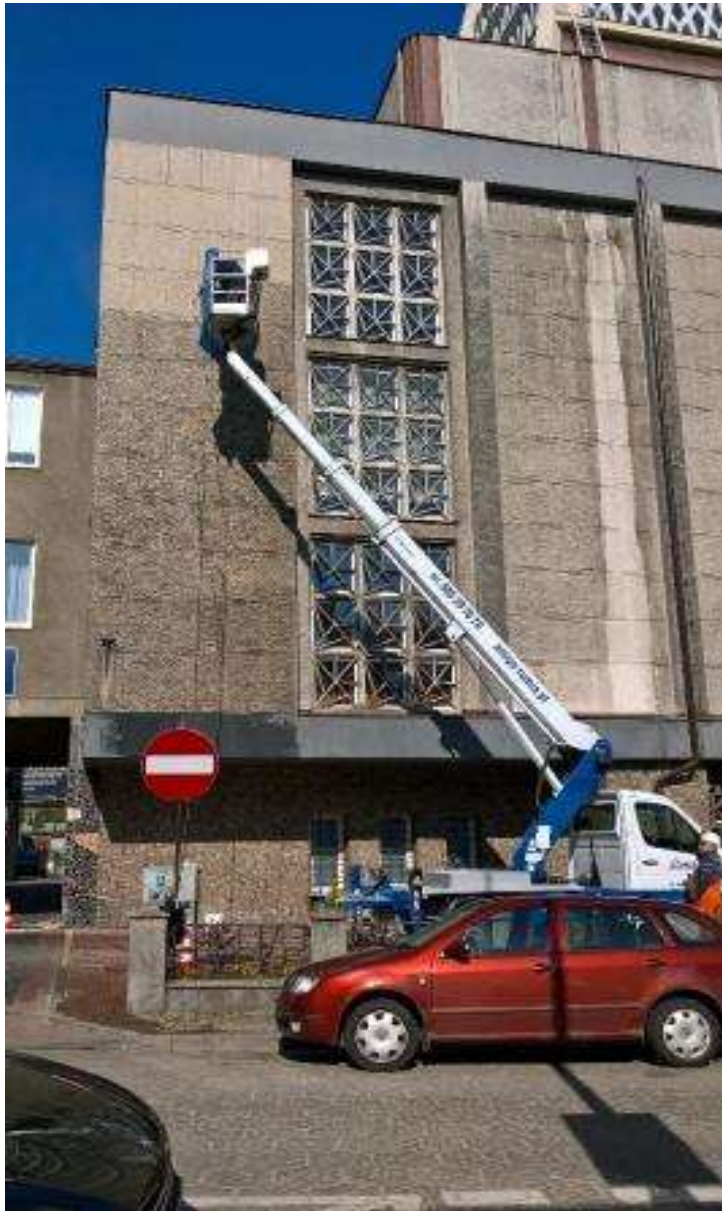
Photo 17. Comparison of the structure and color of the facade a) before and b) after its cleaning - on the example of the eastern facade (from the side of Monsignore Hilarego Jastaka Street) (street names as of 2023) (photo by Jacek Bramorski)
