Assessment of Technical Conditions in Adapting a Historic Warehouse's Space Functionality

The aim of the paper is to present the results of the analysis of the technical condition of a historic Warehouse building located in the former shipyard area in connection with the planned construction in the place of the existing location of the production hall warehouse building.

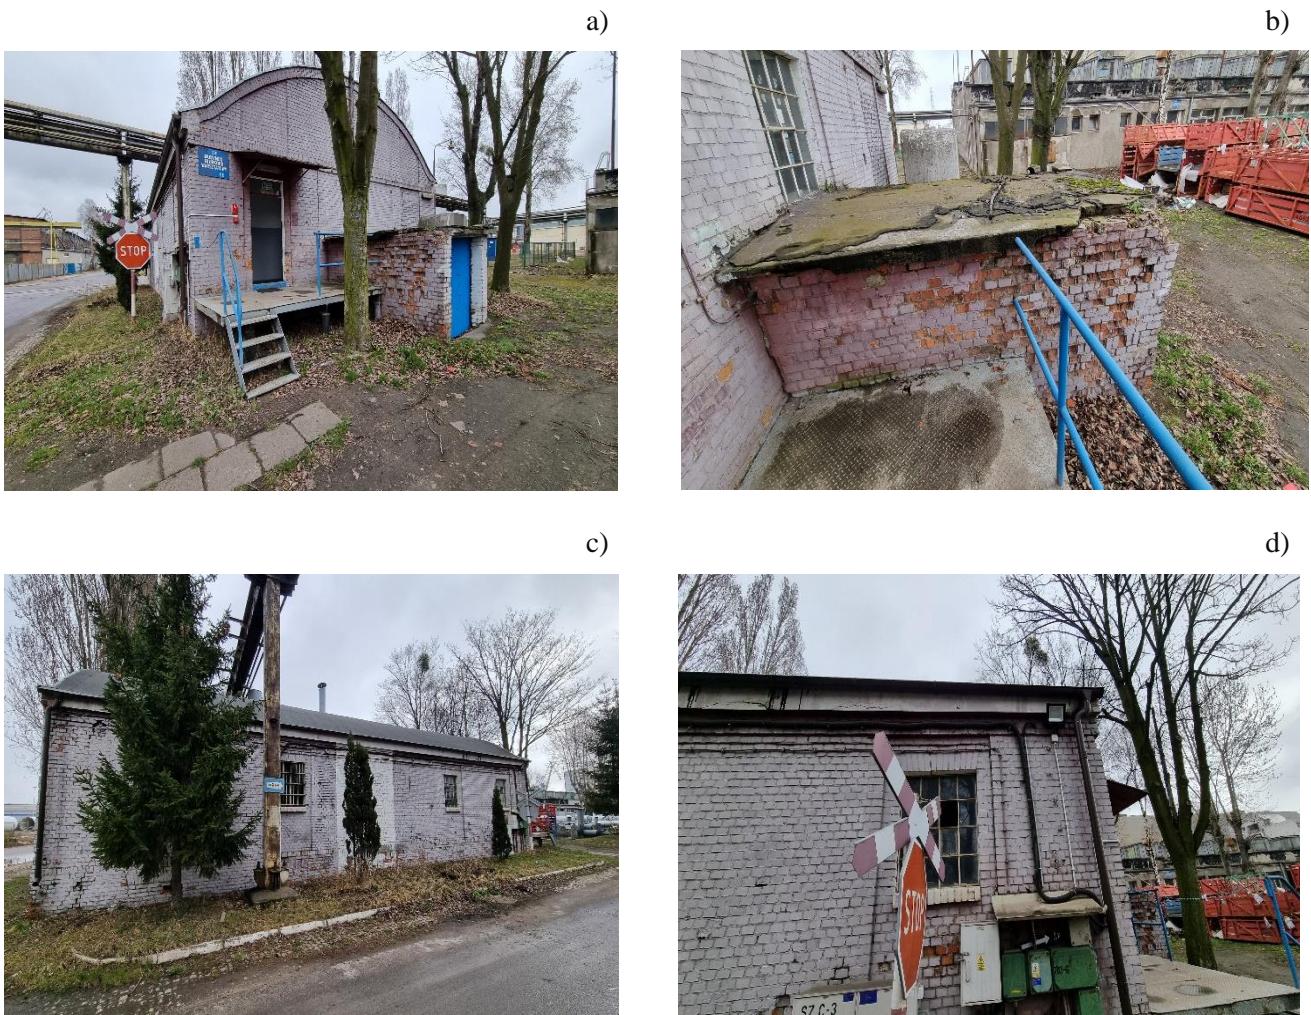
Photo 2. Warehouse building - elevations: a), b) south-eastern, c), d) south-west

Adjacent to the gable wall of the building on the south-eastern façade was an extension made of solid ceramic bricks, 25 cm thick, in which there were gates (entrance doors) to the rooms in the basement level (Photo 2a, b). The walls of the extension, especially under the covering slab, had very extensive mechanical damage, numerous chips and cracks. The level of the top of the annex roof was at the level of the top of the window strip of window openings in the gable wall of the Warehouse building. In the gable wall, the entrance to the Warehouse building led through a steel ramp.

In the view from the south-west façade, the external wall is made of solid ceramic bricks, 25 cm and 38 cm thick, with local thickenings, every ~400 cm, to the interior of the building, resulting from the structure of the covering. The wall was not plastered, like the other facades of the building (Photo 2c, d). There were scratches visible on the wall surface, especially above the bricked-up window arches at the basement level (Photo 2c). Locally, mechanical damage was visible on the wall surface - chipping and missing bricks, weathered joints, some of the joints were empty.

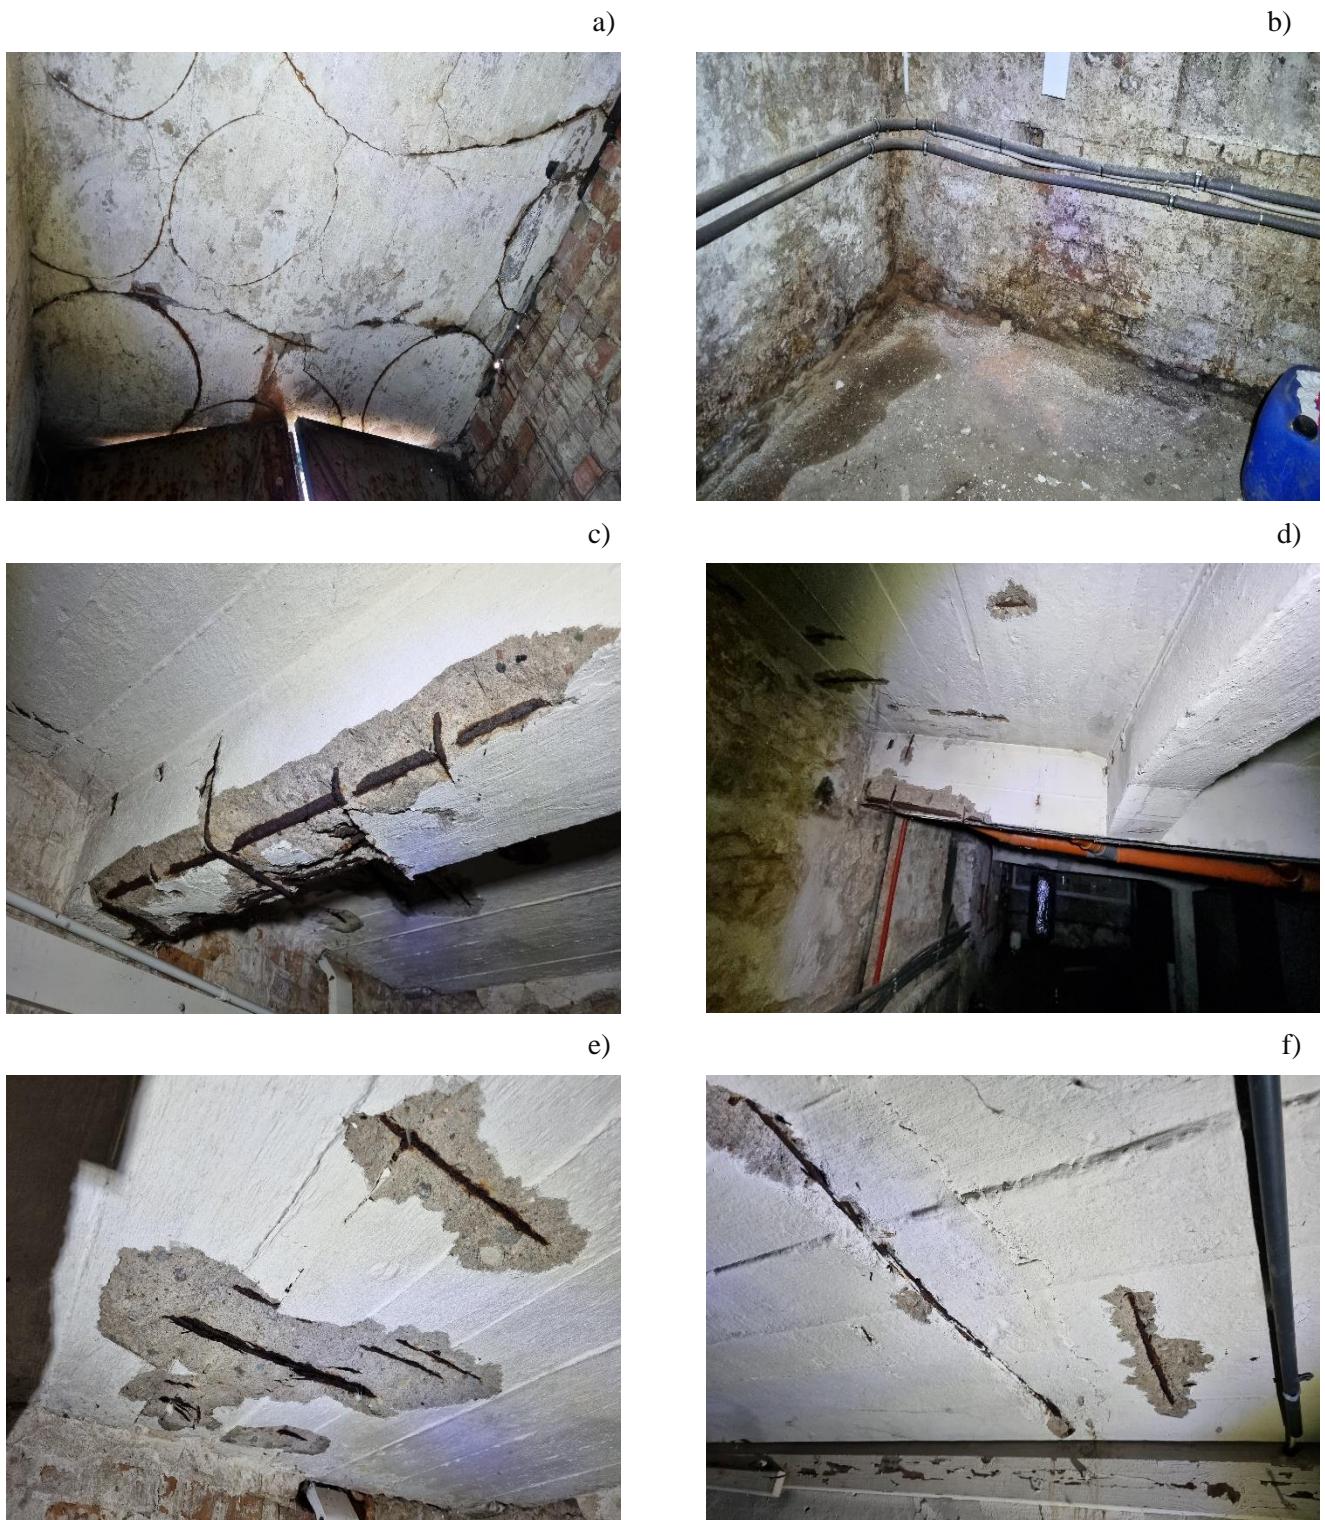
Photo 3. Warehouse Building - elevations: a), b) south-eastern, c), d) south-west Warehouse Building - basement: a) view from the bottom of the ceiling above the annex, b) dampness of the external walls, damage to the concrete cover of the reinforcing bars: c) , d) beams, e), f) ceiling slab

In the view from below, the ceiling of the extension had very intensive damage. It was made as a concrete slab reinforced with metal strips cut from metal barrels (Photo 3a). The strips were partially straightened and arranged as reinforcement elements of the concrete slab. A beam element (steel ceiling beam) was visible in the middle of the extension's length. Both the elements made of metal strips and the steel beam showed corrosion, and traces of moisture were visible on the underside of the covering board.

Intense dampness was visible on the external walls on the basement level (Photo 3b). Moisture intensified in the floor area, especially in the southern part of the building. The floor in the basement was collapsed and cracked, and on a large area of the basement floor the floor was very damp. The monolithic reinforced concrete structure of the ceiling above the basement shows no signs of overload - there were no visible signs of scratching in the middle of the span of both the beams, the internal ribs and the external ribs. There were also no traces of scratches in the area of structural joints, i.e. at the junction of columns, transoms and internal ribs. No signs of overload were identified at the junction of the external ribs with the transoms.

Reinforced concrete elements, in particular beams and internal and external ribs in the zone of external walls, showed very intensive falls of the concrete cover. Reinforcing bars, both the main (structural) reinforcement and the stirrups, showed extensive corrosion, including pitting corrosion (Photo 3c, d). Intensive corrosion damage was also visible on the bottom of the ceiling slabs filling the system of beams and ribs (Photo 3e, f). The rooms on the basement level were not used.

During the inspection, very intensive loss of the concrete cover from the beam elements of the ceiling above the basement was found. The cause of the fall of the concrete cover is the swelling corrosion of the reinforcing bars, both the main reinforcement and the stirrups. In the exposed reinforcing bars, corrosion losses of the main reinforcement bars were found, reaching 20–30% of the cross-sectional area. The cause of corrosion of reinforcing bars is increased humidity in basement rooms. Intensification of moisture damage to the reinforced concrete elements of the ceiling above the basement takes place in the wall zone, where condensation occurs on the basement walls.

A completely technically and economically justified solution, and at the same time recommended from a technical and economic point of view, was the demolition of the existing ceiling above the basement, which had corrosion damage, and the possible subsequent use of fragments (elements of the original structural system as non-load-bearing elements), in accordance with detailed conservation recommendations.

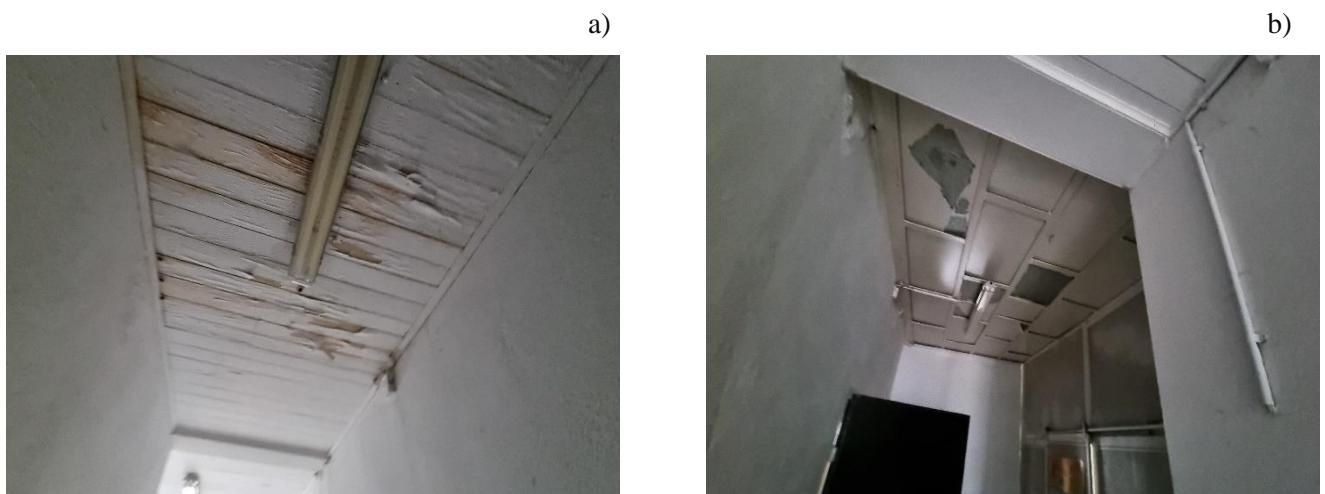
Photo 4. Warehouse building - covering the communication corridor on the ground floor:
a) wooden ceiling lining, b) reinforced glass in steel frames

The rooms on the ground floor were also unused, as was the case with the basement floors. In most cases, the rooms were empty and there were no visible signs of moisture on the external walls. Wire and pipe installations were mostly dismantled, and the hygiene and sanitary rooms were inoperable. In the southern part of the building, the ceiling consisted of a wooden soffit mounted to the structural elements of the covering (Photo 4a), in the central part, at the ceiling level, there was a reinforced glass covering (Photo 4b), while in the northern part the finishing was made of plasterboards.

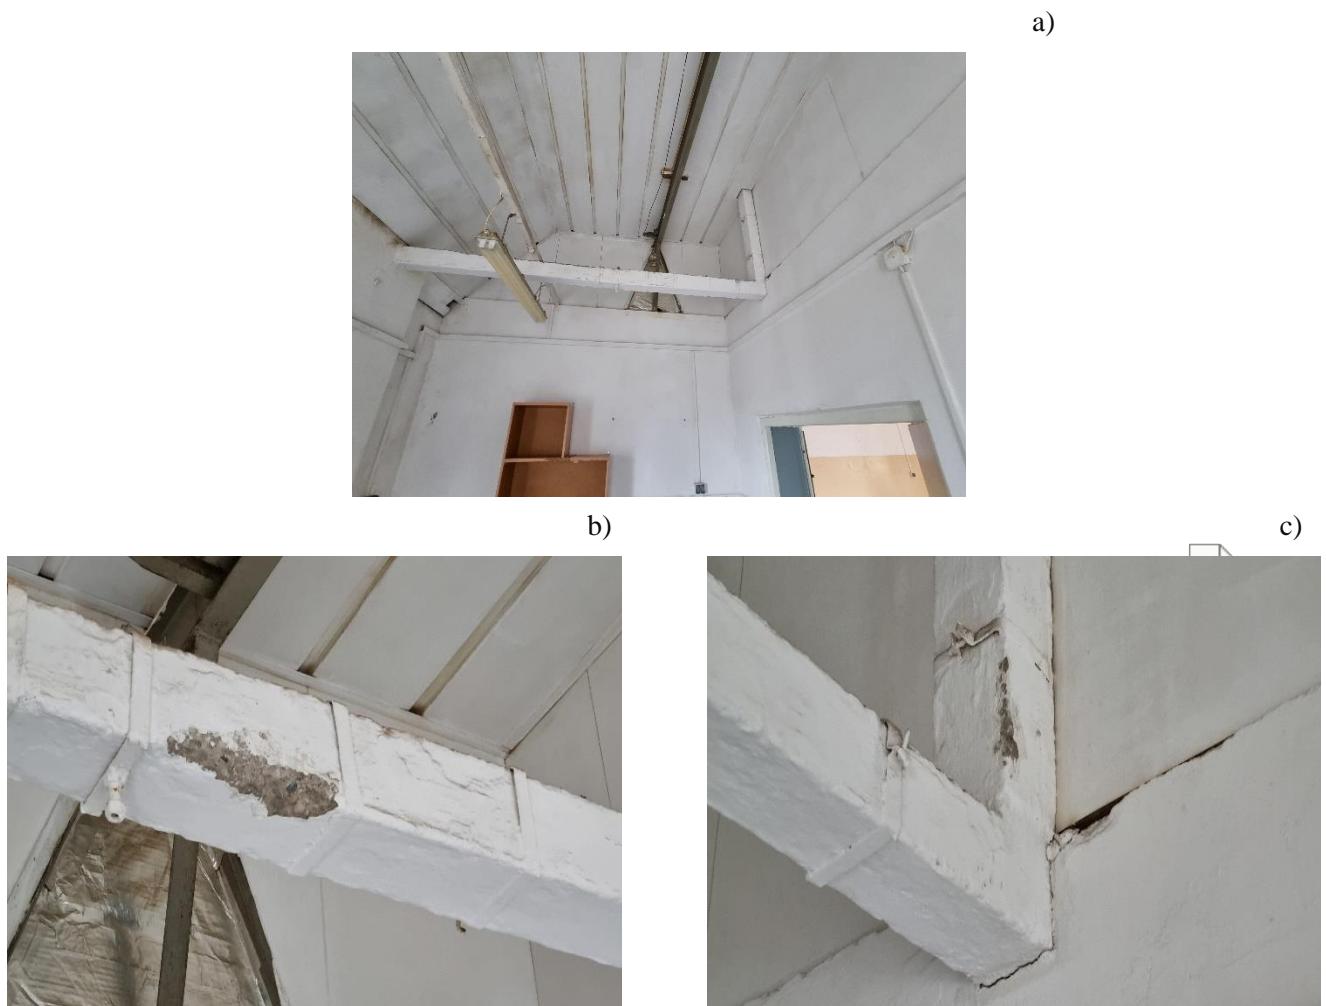
Photo 5. Warehouse building - reinforced concrete tie in the view from the rooms on the ground floor:
a) general view, close-up: b) horizontal element - horizontal tie, c) vertical element - post

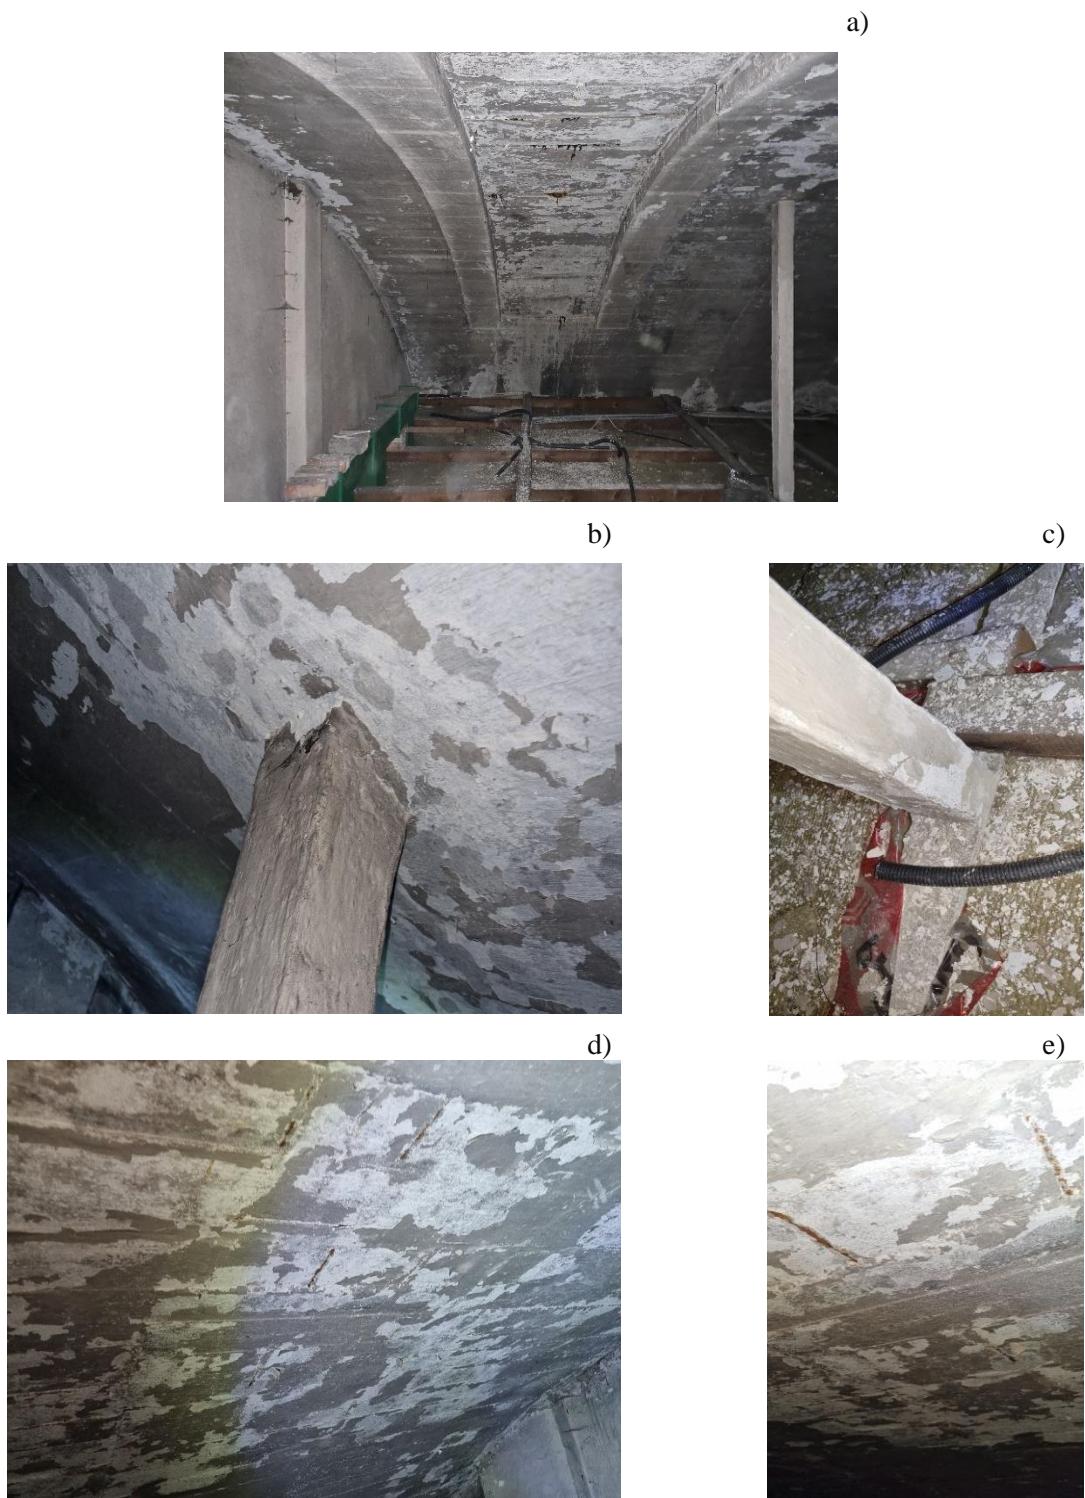
Photo 6. Warehouse building - attic space: a) stiffening ribs below the curvilinear covering slab, connection: b) post - curvilinear covering slab, c) post - horizontal tie, d), e) damage to the concrete cover of the reinforcing bars of the curvilinear covering slab

During the inspection, only part of the attic was possible (Photo 6a). The view from the bottom of the slab arch showed traces of moisture, the concrete cover was falling off locally, and corrosion of the reinforcing bars was visible (Photo 6a, d, e). The spacing of the reinforcing bars was on average 30 cm. There were no visible signs of damage where the posts were connected to the slab arch (Photo 6b), similarly to the case where the posts were connected to the tie (Photo 6c).

The curved surface of the arch, viewed from the bottom, showed traces of the reinforcing bar cover falling off, which was caused by swelling corrosion of the reinforcement resulting from the moisture of the concrete element.

There was no visible damage in the places of installation (suspension) of the reinforced concrete posts to the bottom of the slab arch surface - no detachment of the posts from the roof surface was observed. The connections of the posts with the tie rods were also undamaged - there were no visible scratches. During the inspection, no buckling of either the posts or the tie rods was found. In the place where the slab arch rests on the longitudinal walls, in the view from the bottom of the covering, no damage in the form of cracks or scratches was identified.

A completely technically and economically justified solution, and at the same time recommended from a technical and economic point of view, was the demolition of the existing roofing constructed as a slab arch with ties and the possible subsequent use of fragments of the original elements, in accordance with detailed conservation recommendations.

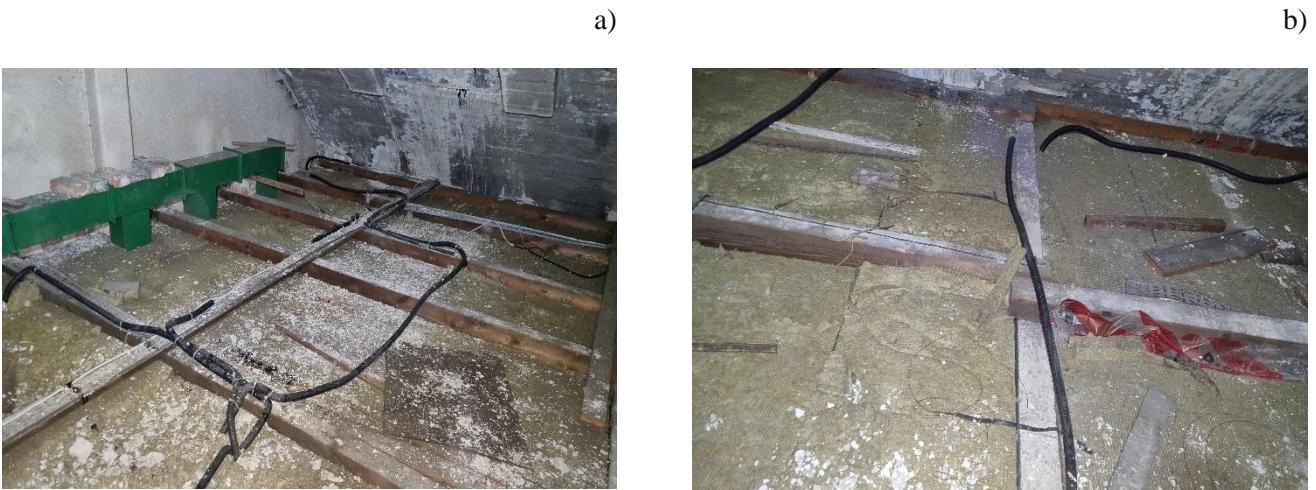
Photo 7. Warehouse building - attic space: a) arrangement of wooden ceiling beams of the covering structure above the ground floor, b) supporting wooden ceiling beams on a horizontal tie
