Emergency condition of the ceramic facade of a residential building

Maciej NIEDOSTATKIEWICZ*¹

¹Faculty of Civil and Environmental Engineering, Gdańsk University of Technology, Gdańsk, Poland

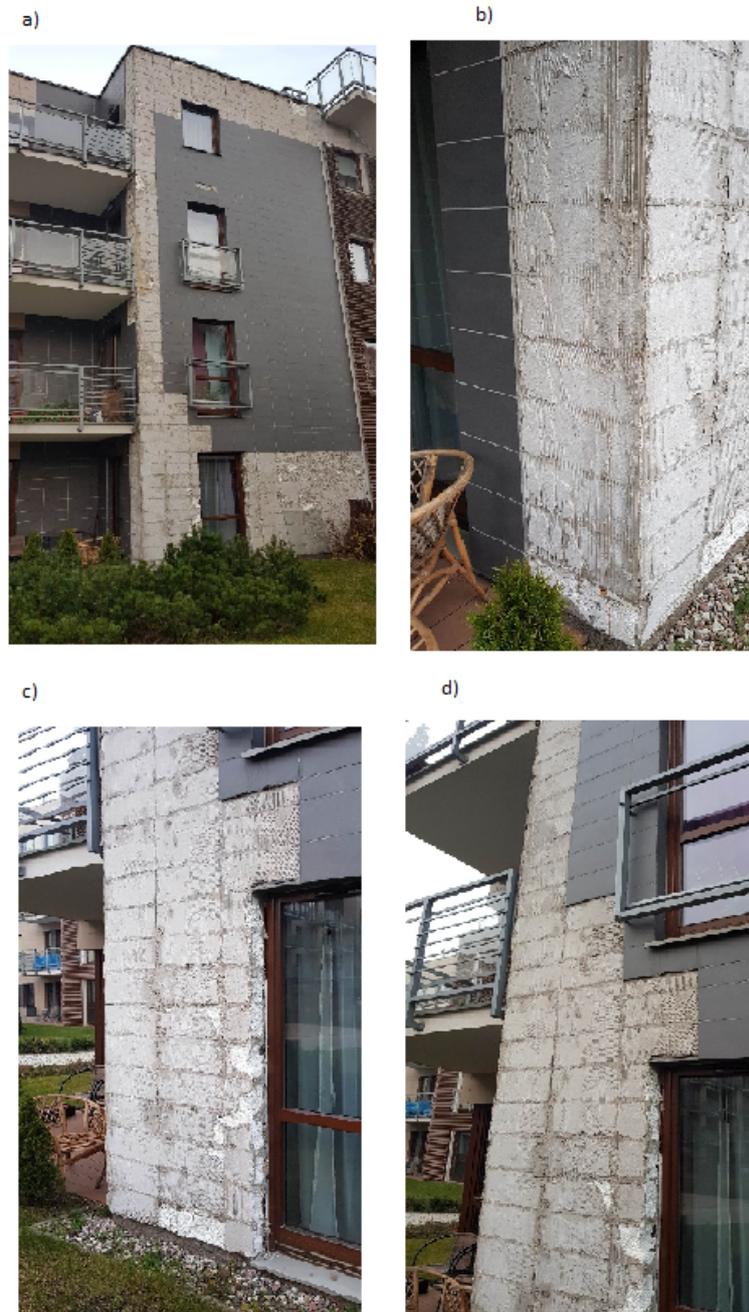
On the facade fragments made of ceramic tiles, extensive blooms were visible, occurring at the joints between individual ceramic tiles. 50% of the facade surface made with the use of ceramic cladding had damage in the form of its detachment from the substrate, i.e. from the adhesive layer, made on a heat-insulating material such as polystyrene. These damages occur over the entire height of the building, at the height of 4 above-ground storeys (Fig. 1).

Figure 1. Damaged ceramic cladding a), b), c) and d) of the building facade

In the case of damage to the ceramic cladding of the building façade, it was most likely a consequence of using too little water added to the adhesive, which resulted in its drying too quickly instead of the spread of bonding over time. Carrying out cladding works in the period when the wind was probably periodically blowing, which resulted in exceeding the so-called open time and resulted in the glue drying out, and consequently accelerated setting start contributed to the tiles being scorched by the glue layer. Likewise, the probable performance of works in the period of periodic increased insolation had a negative effect on the adhesion of the adhesive to the substrate and to the tiles. In addition, the implementation of the cladding fragments on the thickened adhesive layer led to excessive shrinkage and loss of adhesion. Leaks in the attic's plinth also contributed to the degradation of the cladding.

Local efflorescence on the ceramic cladding of the building façade resulted from the occurrence of local leaks in the attic roofing, which could result in the penetration of rainwater into the façade finishing layers, which by gravitation resulted in leaching of calcium compounds. In addition, the locally increased diffusion of water vapor transported to the outside leaches calcium compounds from cement mortars, and the limited transport surface, which is a grout, also made as cement-based mortar, contributes to the formation of efflorescence [20].

- disassembly of the damaged ceramic cladding on the entire surface of all facades of the building,
- re-profiling the substrate: gluing an additional layer of facade mesh in places of damage, additional pinning of the thermal insulation material (polystyrene), making a new layer of glue on the entire surface,
- reconstruction of all facades of the building using the facade plaster,
- checking the tightness of flashings and flashing, especially in the area of parapets, taking into account the possibility of their complete replacement.

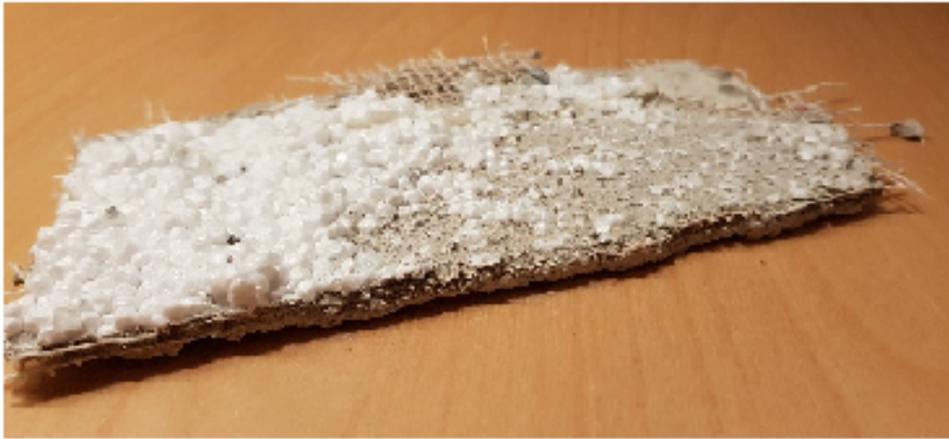
a)

- the pins should be fixed in the first layer of the facade mesh and then covered with the second (top) layer of the mesh with glue - in the outcrops, the use of a double facade mesh and fixing the pins according to the technological requirements (+) was found. The thickness of the glue allows the facade mesh to be fully covered (Fig. 2),

Figure 2. Details of thermal insulation (substrate) a), b) and c) for the ceramic cladding of the building facade

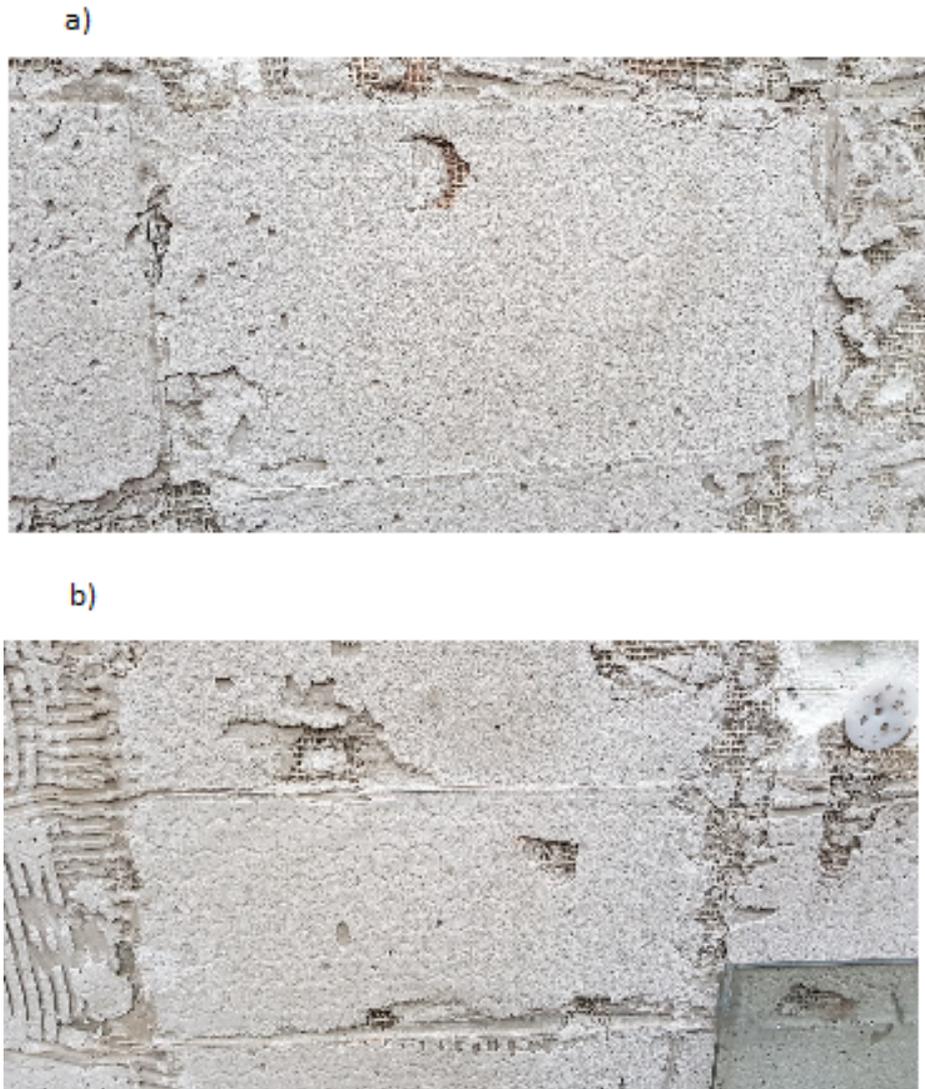
Figure 3. Mechanism a), b) (method of detaching) the ceramic cladding of the building facade
