Integration of BIM and GIS in Predicting Flood Damage to Historic Buildings: The Case of Auschwitz Death Camp I

Andrzej Szymon BORKOWSKI^{1*}, Magdalena KAWKA¹, Karolina MARKOWSKA¹,
Zuzanna MOLAK¹

¹Warsaw University of Technology, Faculty of Geodesy and Cartography, Warsaw, Poland

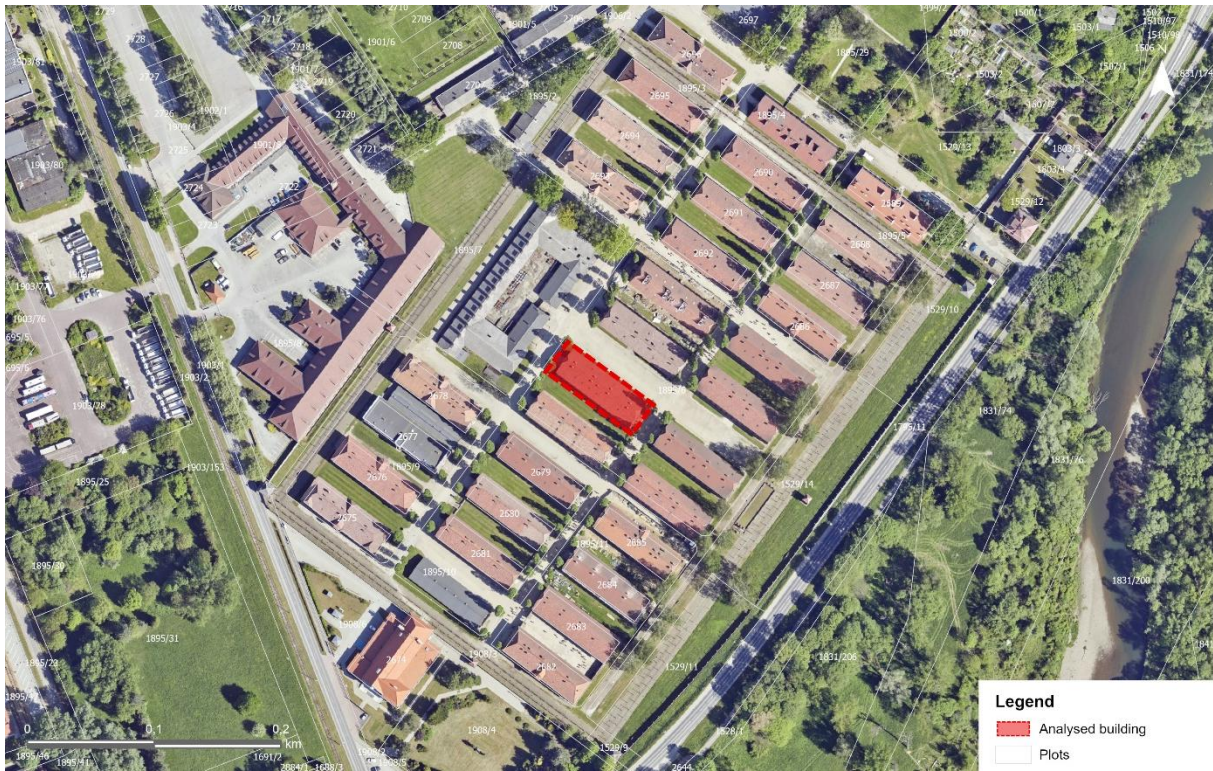
Fig. 2. Location of the investigated object against the background of the former Auschwitz I concentration camp area (own elaboration)

The subject of the study was Building No. 17, located on the site of the former Auschwitz I concentration camp (Fig. 2). This building, which originally served as a residential barrack, is in the central axis of the camp, directly adjacent to the main square. The selection of the building was based on the availability of source materials that were able to be collected in preparation for the research work.

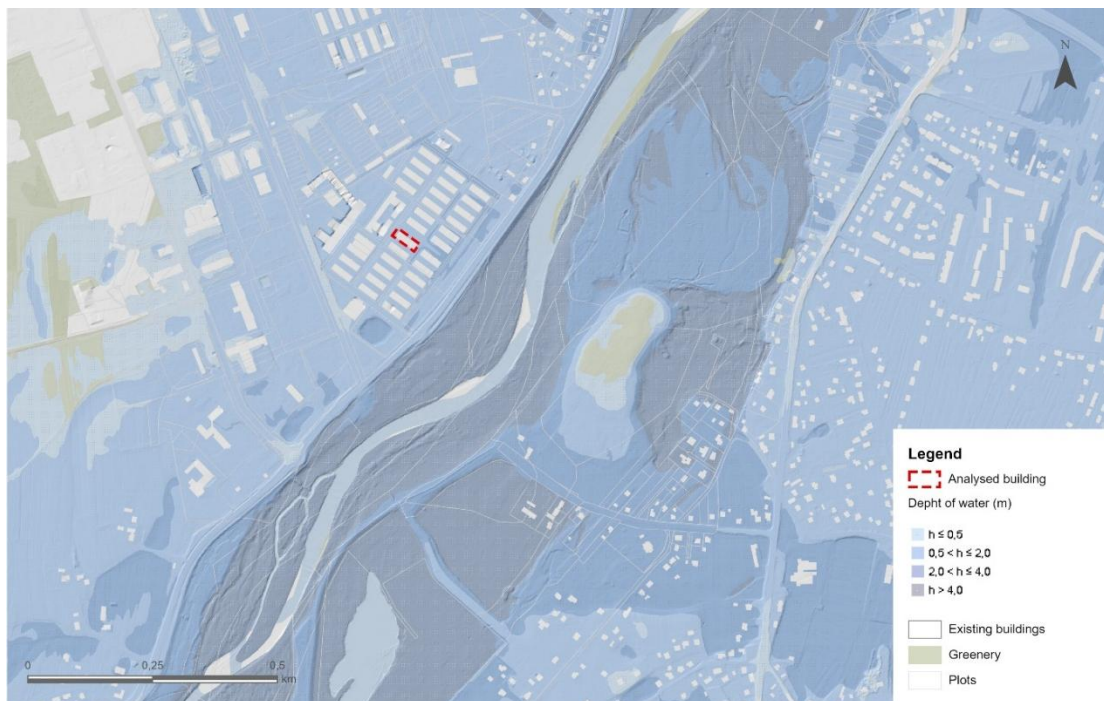
Fig. 3. Projected water height in case of failure, damage or destruction of damming structure (own study)

According to maps prepared by the State Water Company, building number 17 is in an area of special risk of flooding in the event of failure, damage or destruction of a water damming structure (PGW Wody Polskie n.d.). The projected consequences of such an event include the possibility of flooding with depths ranging from 0.5 meters to 2 meters, which could pose a significant threat to the infrastructure and cultural assets located in the area (Fig. 3).

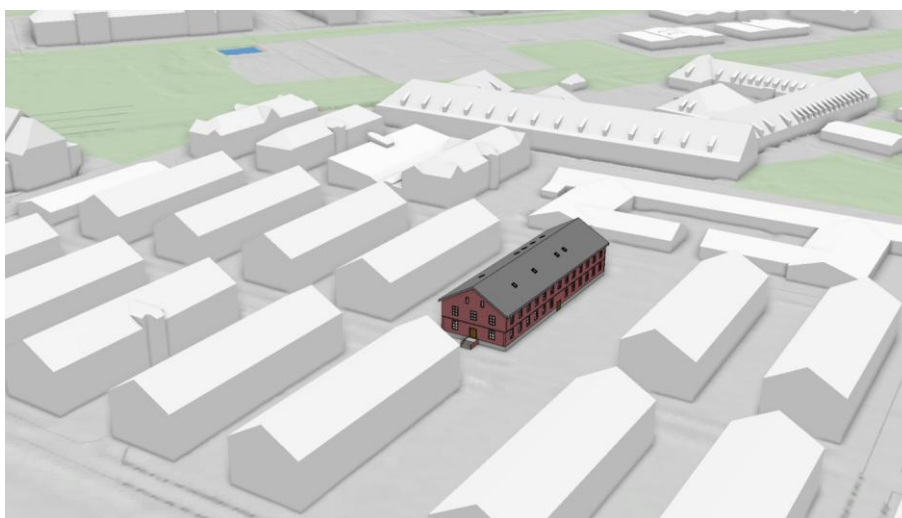
Fig. 5. Integration of the BIM model in a GIS environment (own study)

To integrate the GIS environment with the BIM model, a local scene was created in ArcGIS Pro. Using publicly available data, DMT (Digital Terrain Model) of the analyzed area and existing buildings in LoD2 (Level of Detail 2) in the CityGML standard were obtained from the Geoportal service. Using the obtained data, a local scene with existing buildings located at the appropriate height above sea level was developed. The created BIM models in IFC format were imported into the created scene (Fig. 5). Using the publicly available WMS (Web Map Services) standard, a layer depicting the flood hazard area of the Tresna Reservoir as a result of the destruction or damage of the damming structure was loaded into the analyzed scene. The conversion resulted in a flood hazard layer in .shp (Shapefile) format, which was then given an appropriate height using the *Extrusion* tool.
