Revitalizing the Sacral Complex of the Parish of the Sacred Heart of Jesus in Gdynia: A Comprehensive Restoration Project in Alignment with Monument Conservator's Guidelines and Technical Prerequisites

Maciej NIEDOSTATKIEWICZ^{*1}, Jacek BRAMORSKI^{2,3}

¹ Department of Engineering Structures, Faculty of Civil and Environmental Engineering,
Gdańsk University of Technology, Gdańsk, Poland

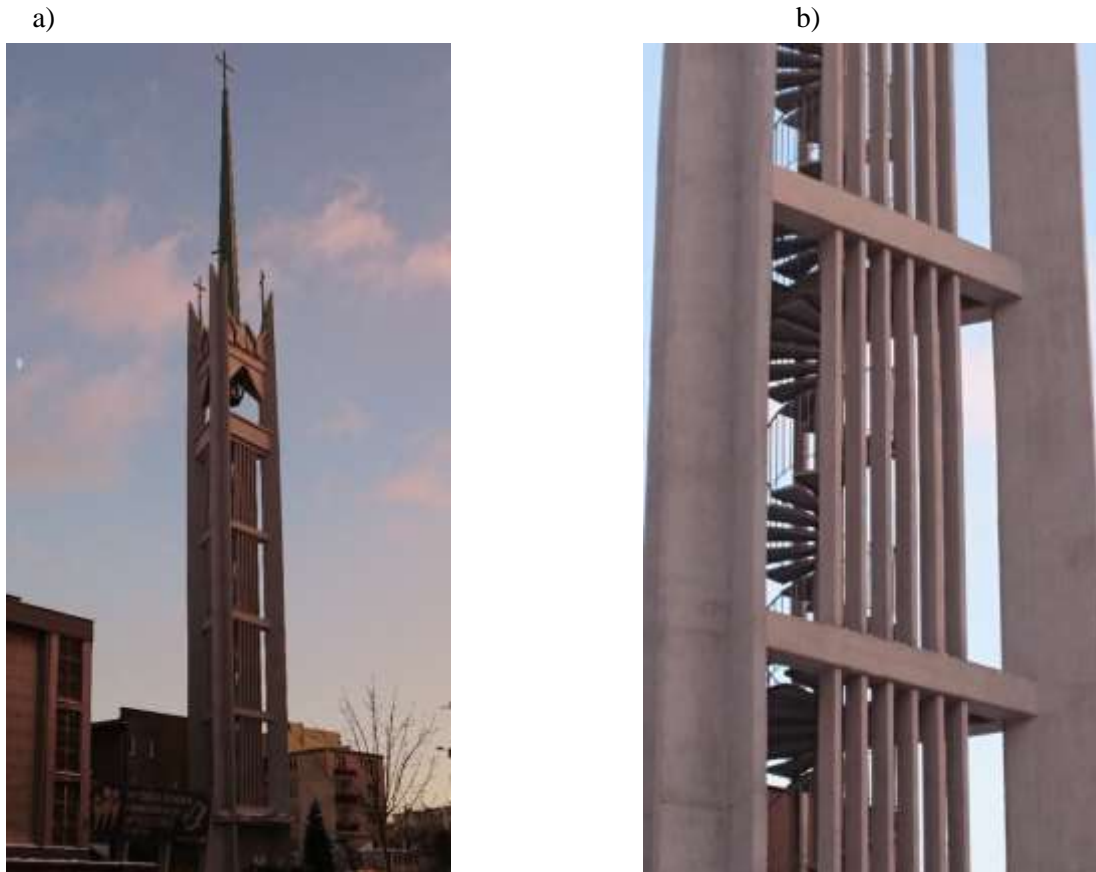
Photo 1. The bell tower of the Church of the SHoJ in Gdynia: a) general view, b) close-up of the internal staircase (photo by Maciej Niedostatkiewicz)

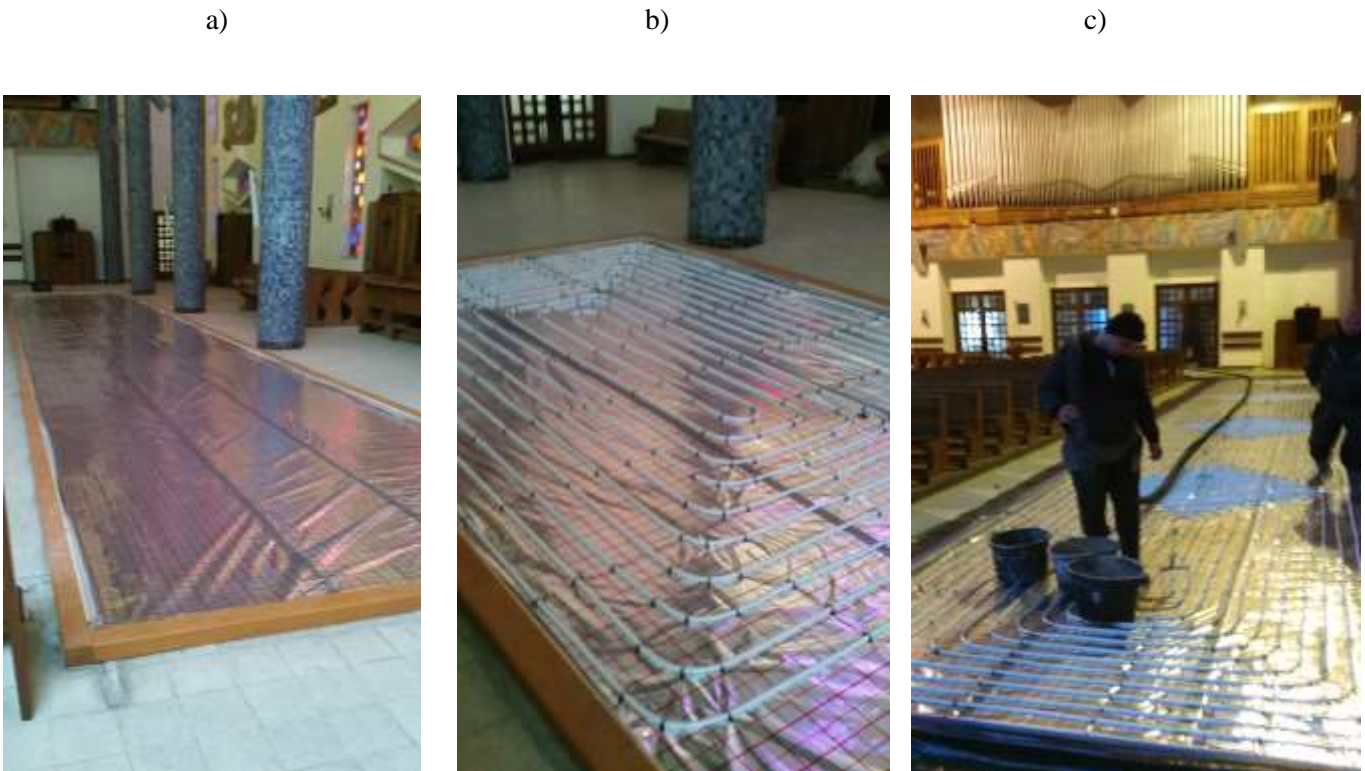
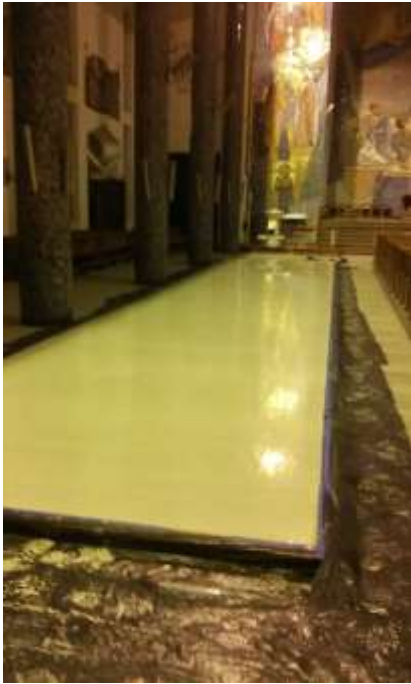
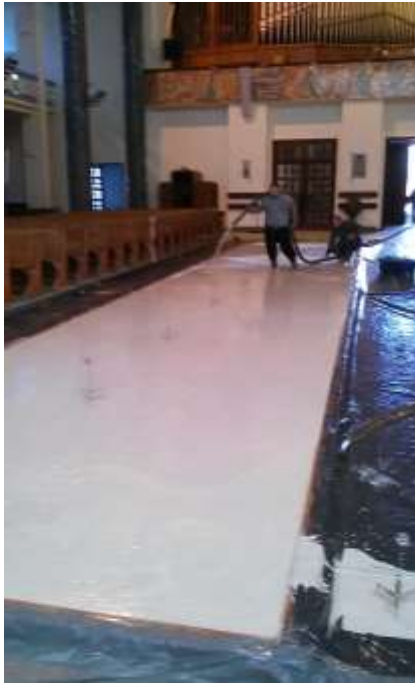
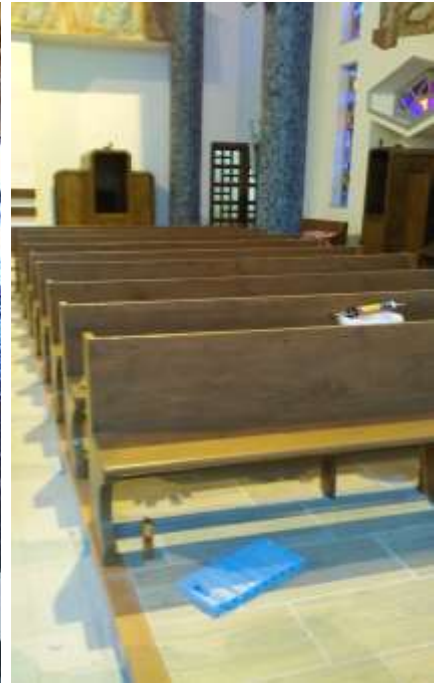
Underfloor heating has been installed in the so-called upper church. Loops with a heating medium were arranged under three rows of benches - the installation of underfloor heating did not require changing the arrangement of the benches, functioning in the so-called the upper church in an unchanged form until it is made available to the faithful. The implementation of the water-type underfloor heating was carried out on the basis of a design study - an executive design. During the works related to the installation of underfloor heating, special attention was paid to the fact that the thickness of the layers of thermal insulation material and the concrete screed was selected in such a way as to protect the heating installation against the possibility of heat loss (thickness of the thermal insulation material) and the possibility of damage to the heating loops (thickness of the concrete screed (anhydrite)), on the other hand, so that the installation of underfloor heating does not make it necessary to rebuild (raise) the existing platforms under the benches. The heating center was installed on the level of the upper church. The individual stages of work related to the installation of underfloor heating in the so-called the upper church is shown in Photo 19.

Photo 19: Installation of underfloor heating in the Church of the SHoJ in Gdynia in the rooms of the so-called of the upper church: a), b), c), d), e), f) stages of work (photo by Jacek Bramorski)
