Assessment of Technical Conditions in Adapting a Historic Warehouse's Space Functionality

The aim of the paper is to present the results of the analysis of the technical condition of a historic Warehouse building located in the former shipyard area in connection with the planned construction in the place of the existing location of the production hall warehouse building.

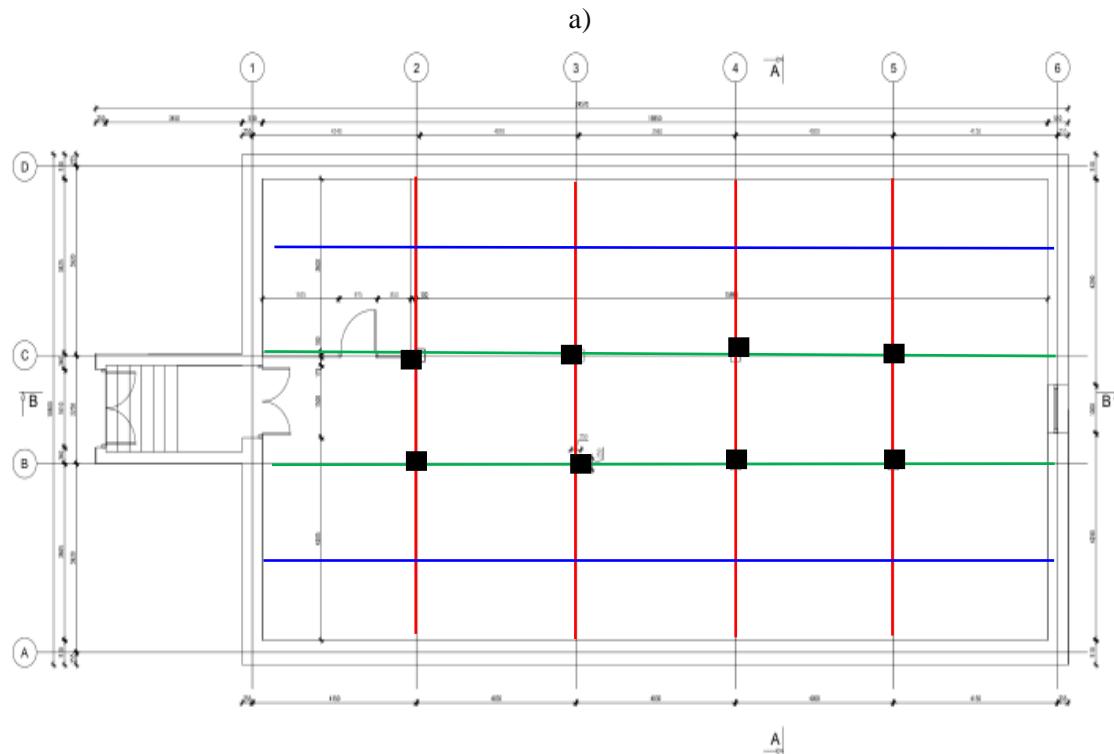
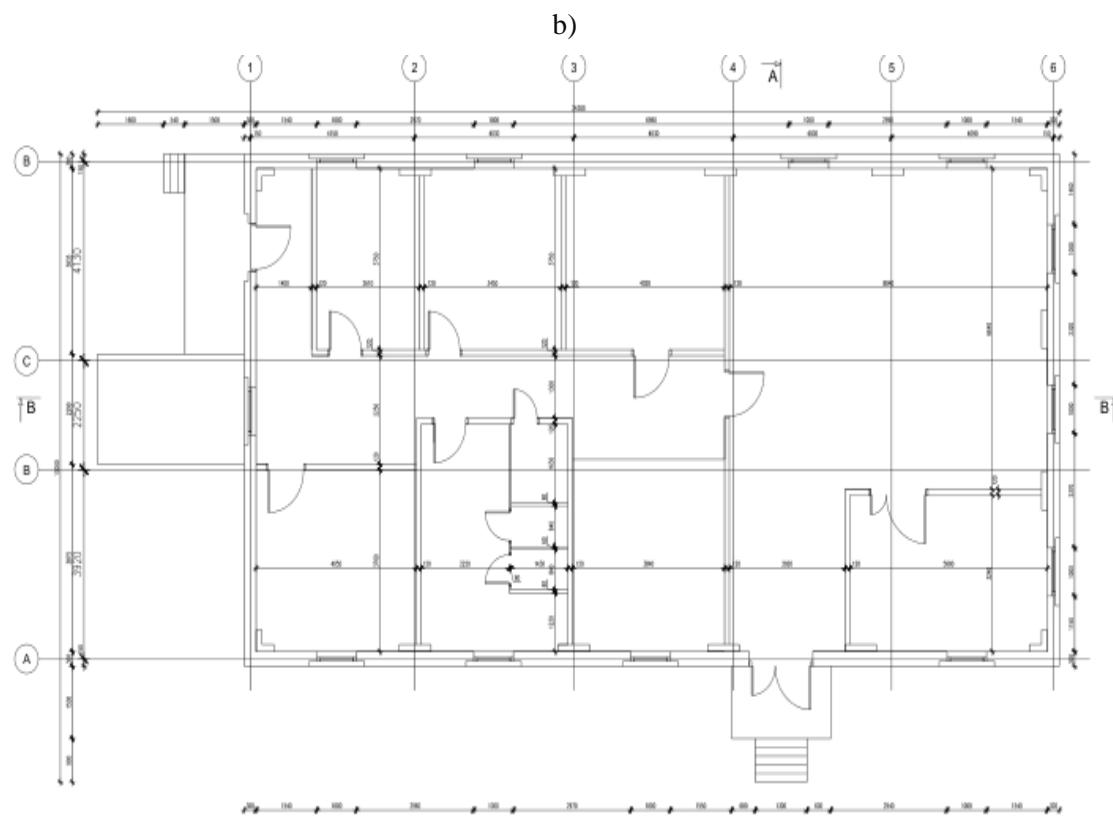
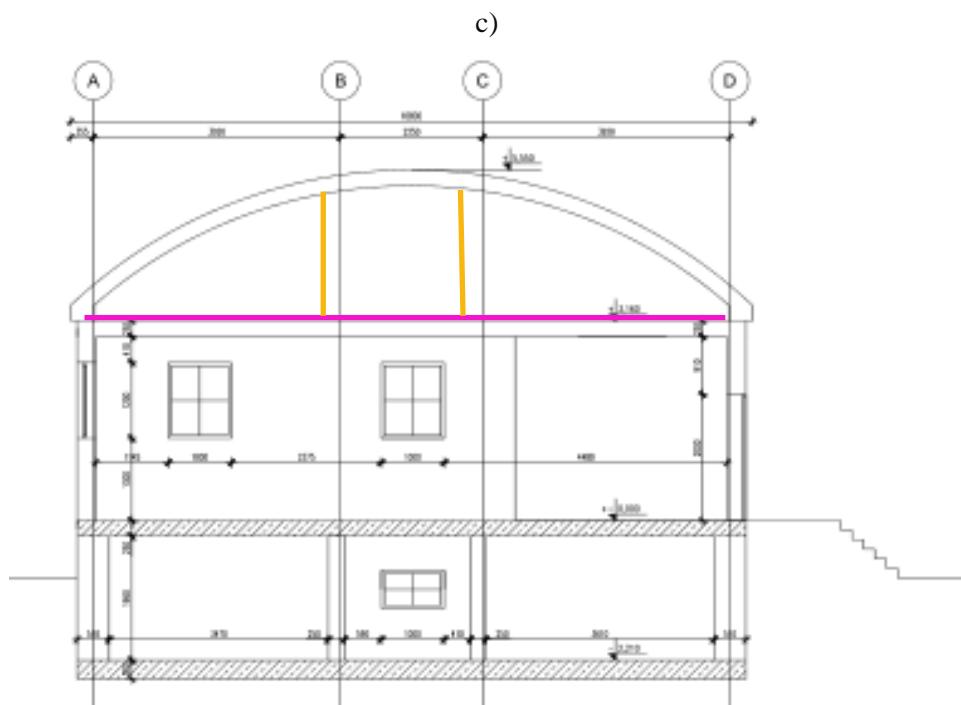
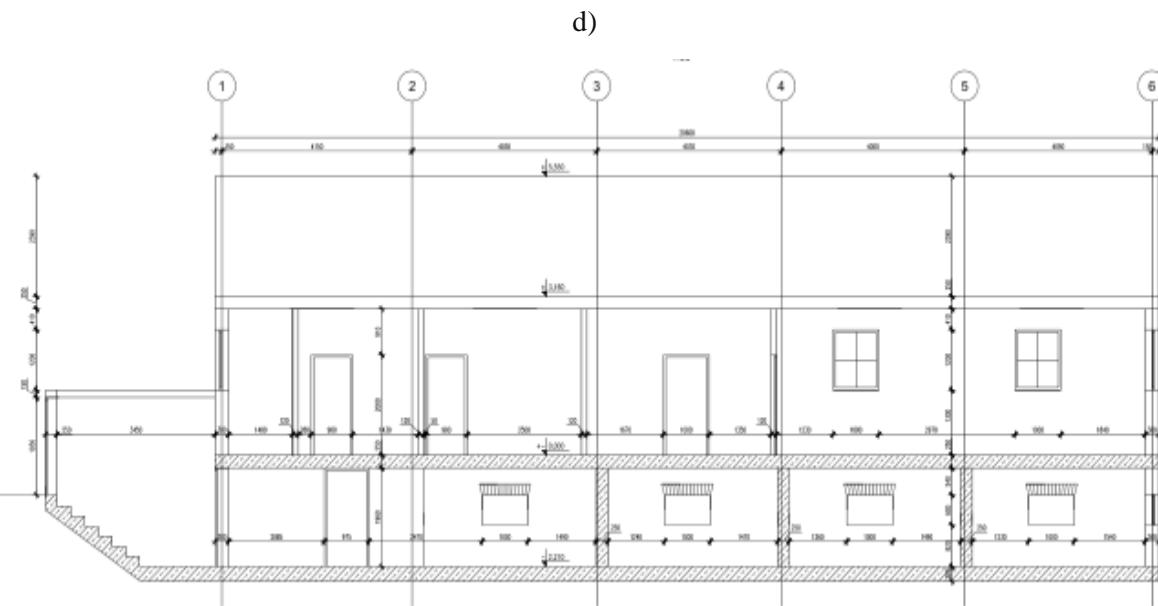
Fig. 1. Warehouse building: projections: a) basement floors, b) ground floor, cross-sections: c) transverse, d) longitudinal (*based on inventory*) continued
